Roof Condition Analysis

John Evans Middle School - Gym Dome

Inspection Date: February 24, 2012

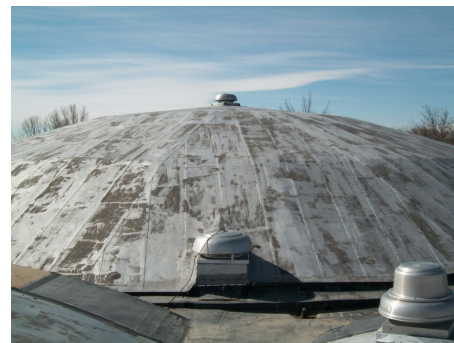
Drainage and Leak Details: Roof Drainage at Built-In Gutters:
This roof system is properly drained due to the dome configuration. However, excessive ponding water was observed in the built-in gutter system located at approximately 1/2 of the circumference of the dome.

Ponding water on asphalt based roof systems is known to accelerate the aging process through emulsification which can cause premature failure of the roof system. Ponding water on any roof can threaten the structural integrity due to the increased weight load. Most roofs are not designed to accomodate ponding water conditions.

Roof leaks that occur on roofs with good drainage often result in minimal damage to the building's interior and contents. Roof leaks that occur under ponded water conditions can cause catastrophic damage to both the roof system and the buildings interior and contents. Ponding water conditions should be corrected.

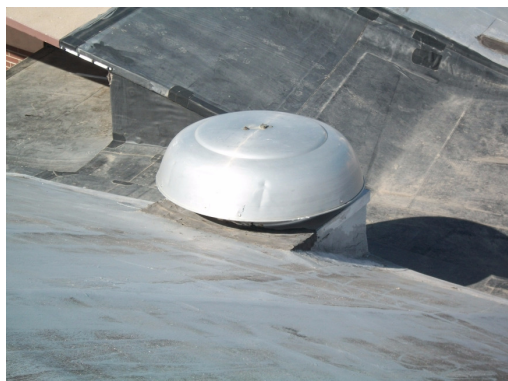
Photo #: 9

Type: Low Flashing Height

Severity: Minor

Details: **Low Flashing Height at Curb:**
Good roofing practice dictates that all curb flashings shall be a minimum height of 8" above the roof membrane surface to prevent moisture infiltration from snow, ice and blowing rain.

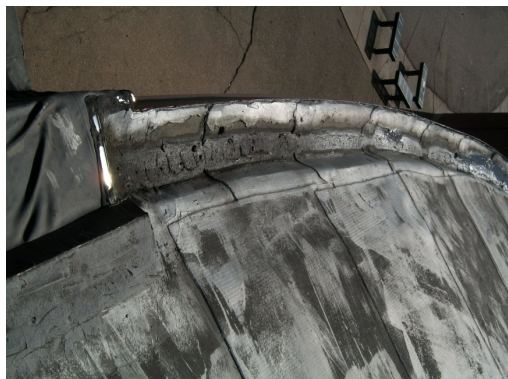
Photo #: 8

Type: Ponding Water at Gutter System

Severity: Major

Details: **Ponding Water at Gutter System:**
The NRCA has classified "undesirable" ponding water as standing for more than 48 hours though ponding can pose a threat in even shorter time spans. A matter of "deep" concern in the roofing industry is the fact that a 1" deep pond weighs 5.2 lbs / square foot and many structures can not handle this extra load.

Ponding water can be traced to any of several factors. First, a roof may pond water as a result of poor housekeeping on the roof which contributes to clogged drains, gutters and downspouts. The build up of roof top debris or displaced gravel ballast frequently blocks water flow and creates ponds. Secondly, the building's roof top drainage system may not have been designed properly. Finally, ponds form as a result of such common conditions as building settlement and deck deflection.

Since ponds occur in low areas of a roof, a pond becomes a repository for debris, sediment, and chemical emissions. Ponding encourages microorganism and bacterial degradation, roof deflection, magnified ultraviolet exposure and ultimate premature failure of the roof system. If the roof membrane in a ponded area sustains damage, all of this water may drain into the roof system and into the building.

The additional weight load may pose a threat to the structural integrity of the building, with a very real possibility of collapse of the roof in extreme cases.

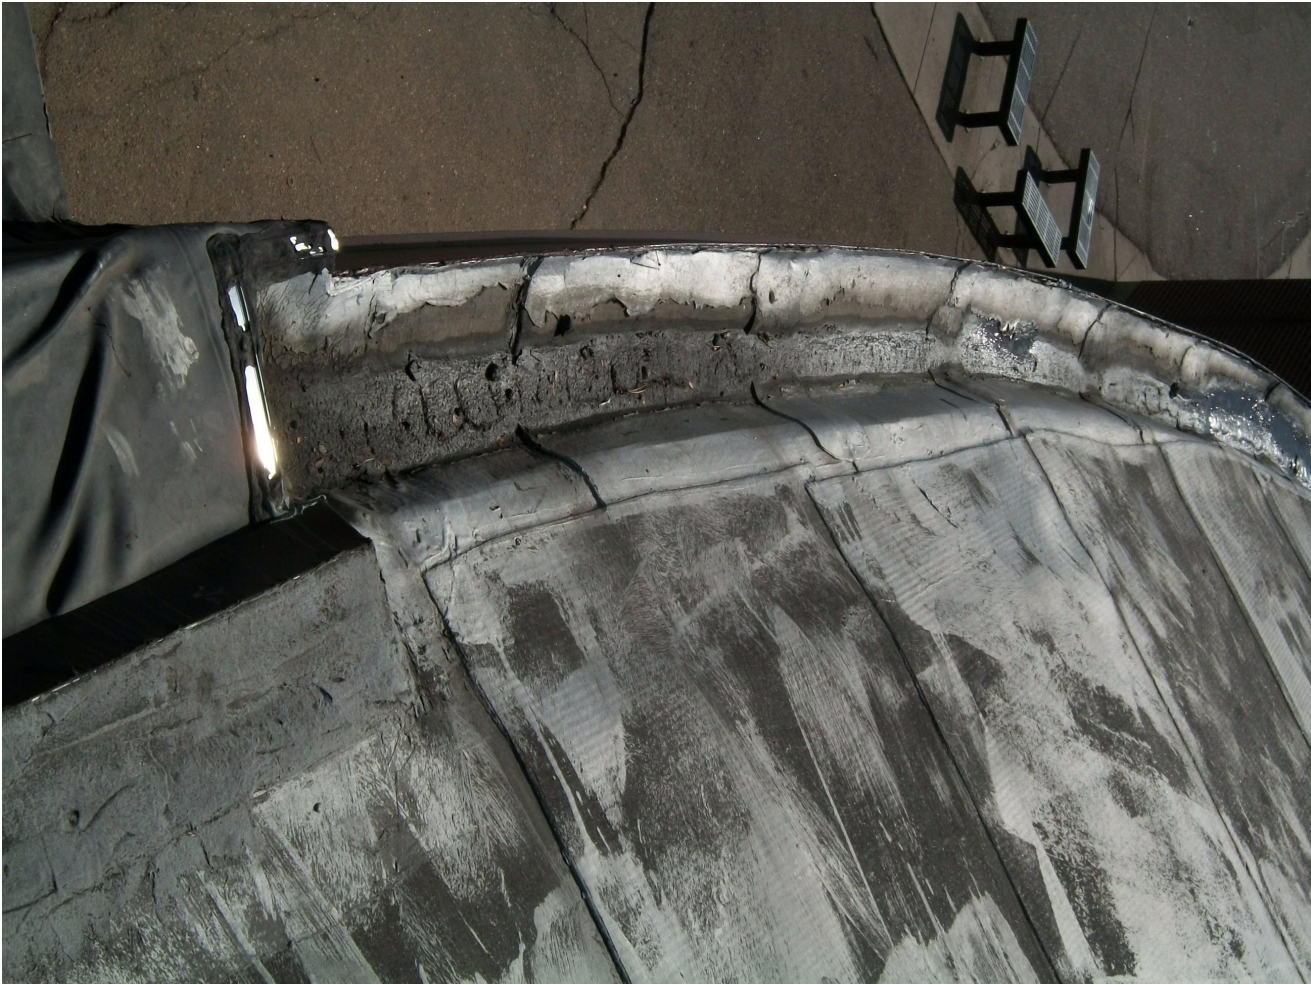
Ponding Water at Gutter System

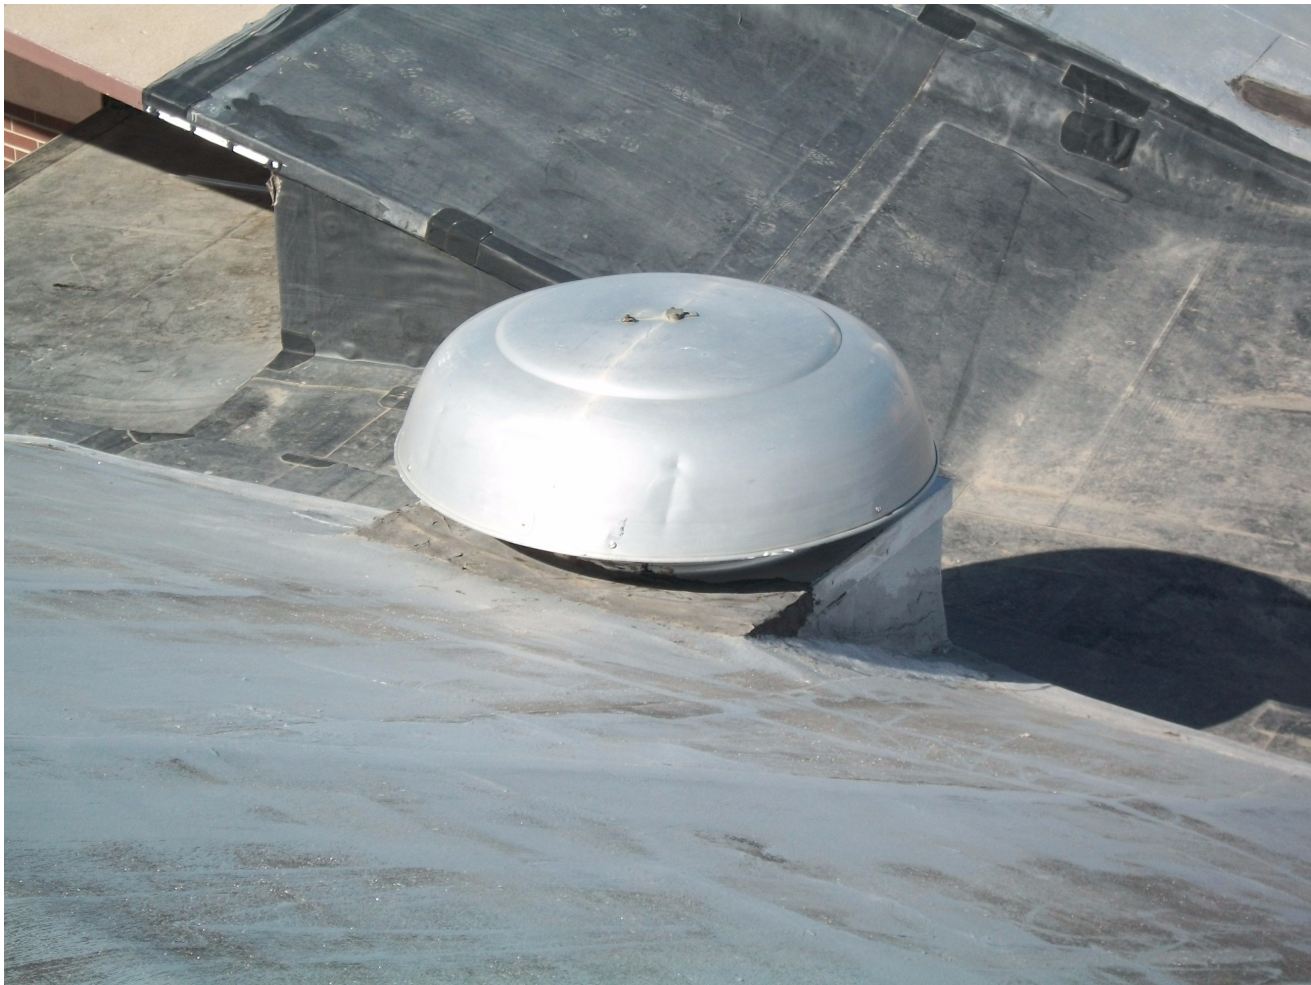
Low Curb Flashing Height
